January 8, 2020

Re: Post Construction Indoor Air Quality Screening and Consulting Support Services Holland Hill Elementary School

Woodard & Curran has prepared this summary report of indoor air quality (IAQ) screening results following construction activities at the Holland Hill School located at 105 Meadowcroft Road in Fairfield, Connecticut.

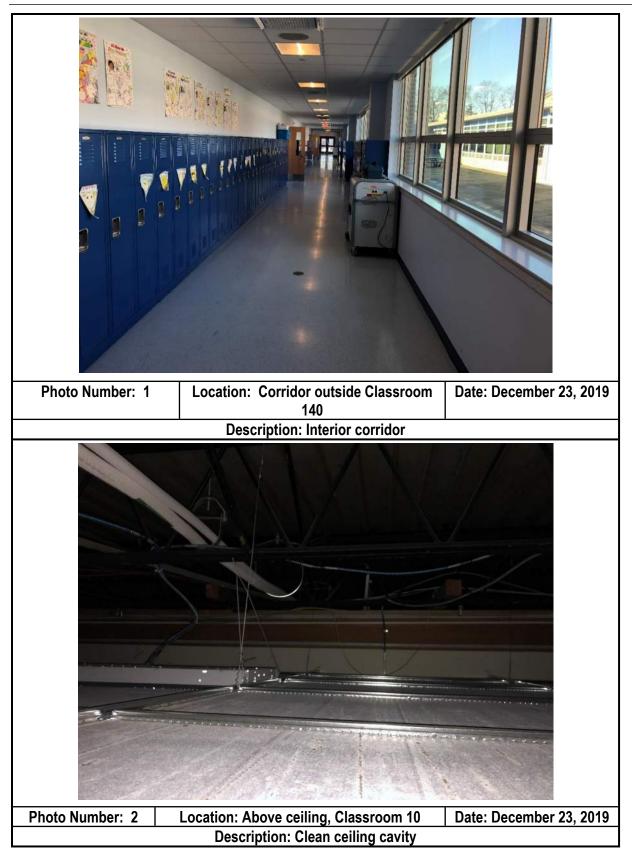
The occupied areas of the building including classrooms and corridors, generally appeared clean and no excessive accumulation of settled dust was observed. The area above the suspended ceilings in select classrooms were also visually inspected and there was no evidence of construction related debris or materials that would be expected to adversely impact the indoor environment. Photos of the corridor outside Classroom 140 and the ceiling cavity above Classroom 10 are included as Photos 1 and 2 in Attachment A.

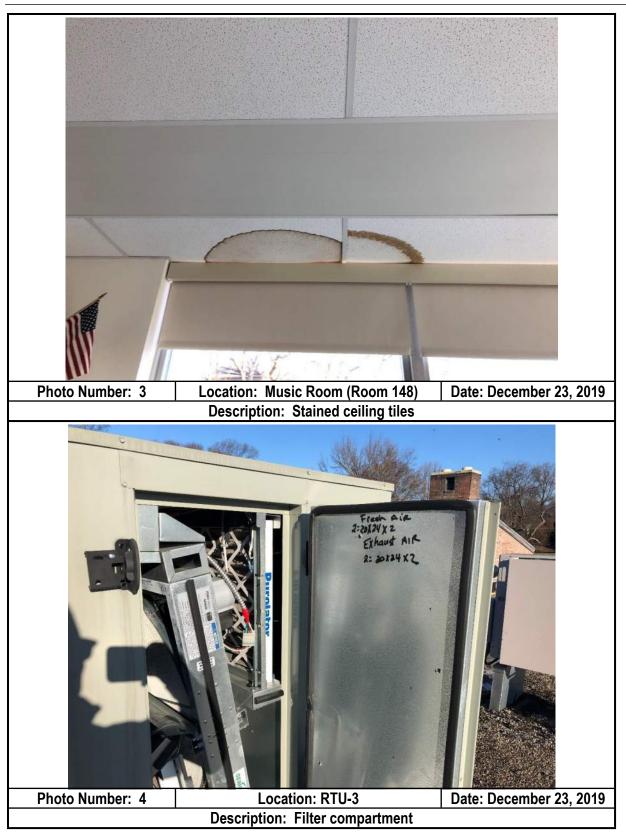
During the inspection stained ceiling tiles were present in the Music Room (Room 148) along the exterior wall. A photo of the stained ceiling tiles is included as Photo 3 in Attachment A. An inspection above the suspended ceiling did not reveal the source of the staining.

The areas of the building intended for occupancy including classrooms and corridors, generally appeared clean and no excessive accumulation of settled dust was observed. Two stained ceiling tiles were observed in the Music Room (Room 148). The stained ceiling tiles in the Music Room (Room 148) should be replaced. The source of the staining should be identified and remediated.

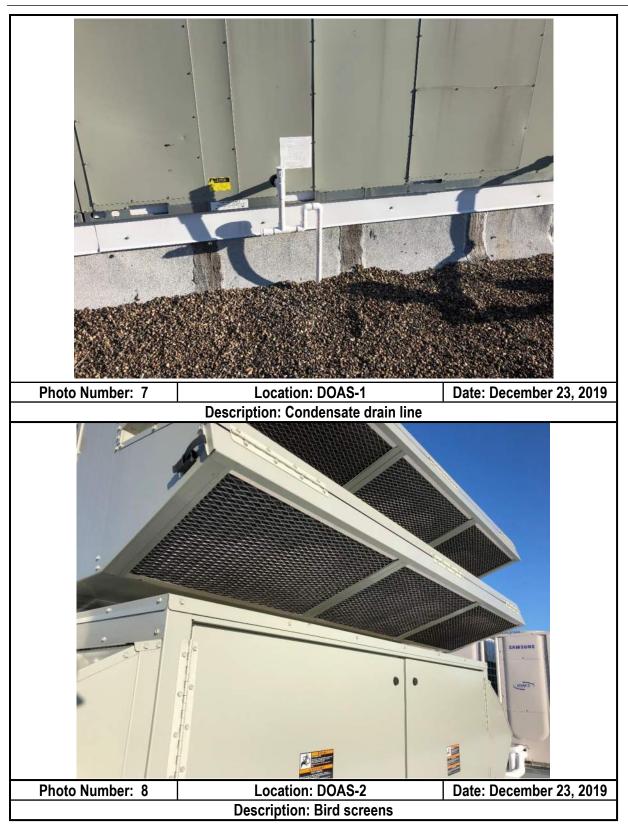
Photo Number: 5	Location: RTU-3	Date: December 23, 2019							
Description: Fan compartment									
Photo Number: 6	Location: DOAS-2	Date: December 23, 2019							
	Description: Prefilters and fresh air dampe	ers

Three of the observed six rooftop air handing units were visually inspected including DOAS-2, DOAS-1, and RTU-3. Photos of these units are included as Photos 4 through 9 in Attachment A. The rooftop dedicated outdoor air systems (DOAS) and rooftop units (RTU) were in good condition. Filters and pre-filters were seated tightly in their tracks, the compartments were clean with no accumulated dust, rust, water or suspect mold growth. The bird screens were also in good condition. DOAS-1 and 2 were operating at the time of the survey; however, RTU-3 was not operating.

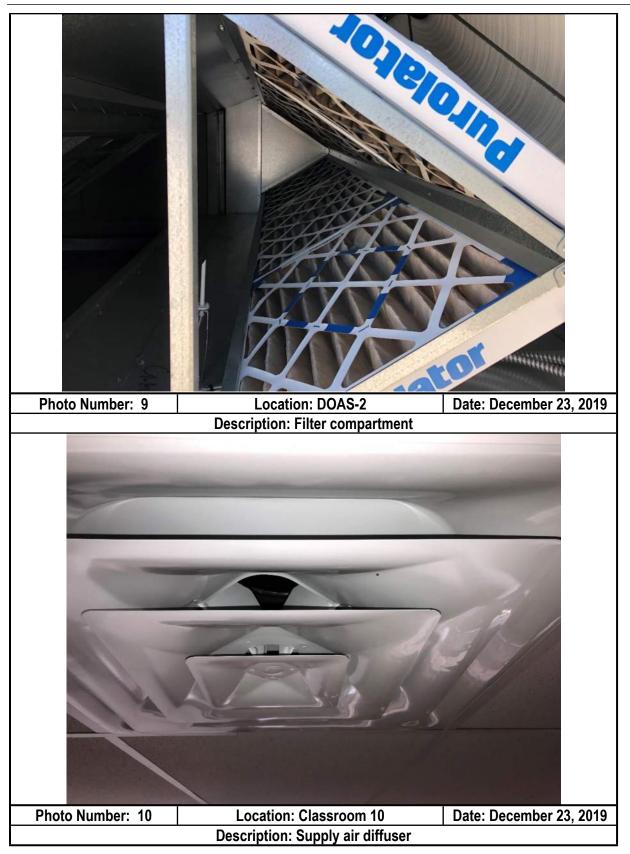
The supply air diffuser fins observed were in good condition and settled dust was not observed. A photo of the supply air diffuser located in Classroom 10 is included as Photo 10 in Attachment A. The observable interior portion of the ductwork also appeared to be in good condition.
