# ON-SITE TESTING g-MAX IMPACT EVALUATION

| <b>Project Name</b> | Fairfield Ludlowe High School Football Field<br>ASTM F1936-19 g-max Impact Evaluation | | |
| <b>Client Info</b> | Fairfield Public Schools<br>501 Kings Hwy. E Suite 210<br>Fairfield, Connecticut 06825 | <b>Site Info</b> | Fairfield Ludlowe High School<br>785 Unquowa Rd<br>Fairfield, CT 06824 |
| <b>Report Date</b> | 6/21/2022 | <b>Test Date</b> | 6/17/2022 |

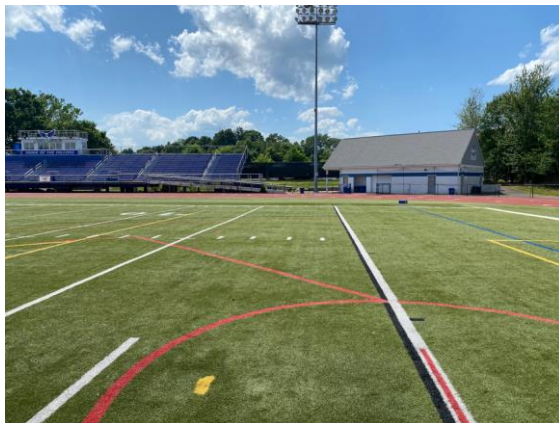
Location #1

| Loc # | Drop # | Gmax (g's) | Location Description | Gmax Avg (g's) | Infill Depth (mm) | Surface Temp (°F) |
|---|---|---|---|---|---|---|
| 1 | 1 | 148 | Goal Line, End A, field centerline | 161 | 24 | 93 |

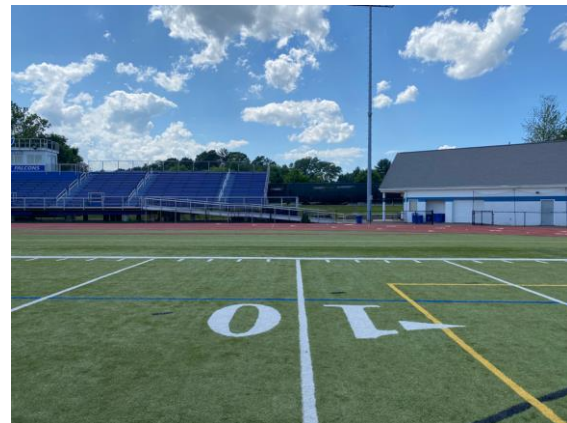
Location #2

| Loc # | Drop # | Gmax (g's) | Location Description | Gmax Avg (g's) | Infill Depth (mm) | Surface Temp (°F) |
|---|---|---|---|---|---|---|
| 2 | 1 | 129 | 10 Yard Line, End A, 63 ft from field centerline to the Side C | 138 | 34 | 93 |

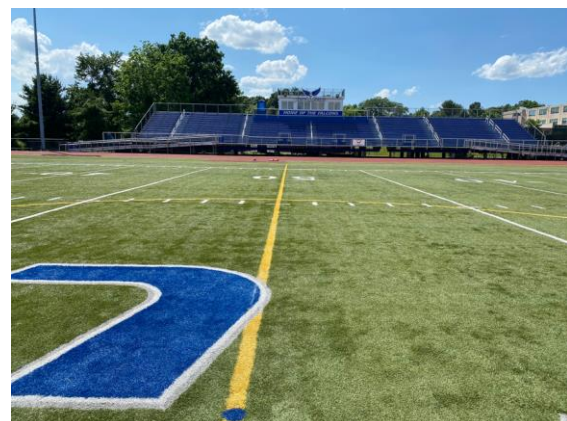
Location #4

| Loc # | Drop # | Gmax (g's) | Location Description | Gmax Avg (g's) | Infill Depth (mm) | Surface Temp (°F) |
|---|---|---|---|---|---|---|
| 4 | 1 | 145 | field centerline | 151 | 34 | 91 |

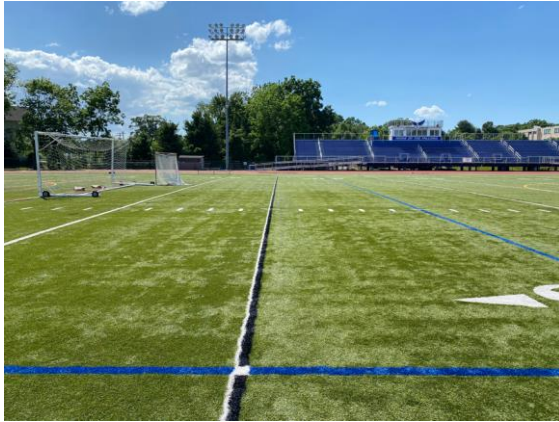
Location #5

| Loc # | Drop # | Gmax (g's) | Location Description | Gmax Avg (g's) | Infill Depth (mm) | Surface Temp (°F) |
|---|---|---|---|---|---|---|
| 5 | 1 | 142 | 25 Yard Line, East end, 63 ft from field centerline to Side D | 153 | 31 | 91 |

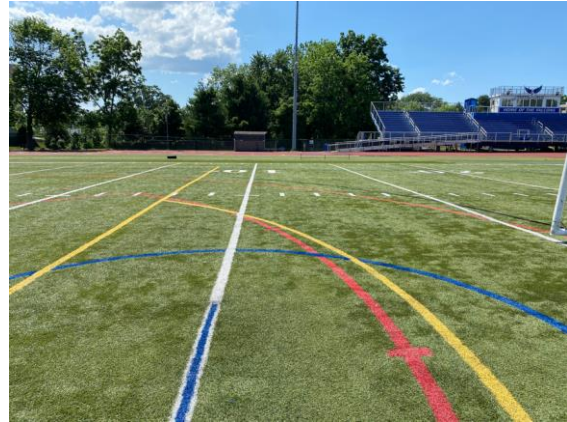
Location #6

| Loc # | Drop # | Gmax (g's) | Location Description | Gmax Avg (g's) | Infill Depth (mm) | Surface Temp (°F) |
|---|---|---|---|---|---|---|
| 6 | 1 | 174 | 12 Yard Line, End B, field centerline | 191 | 23 | 96 |

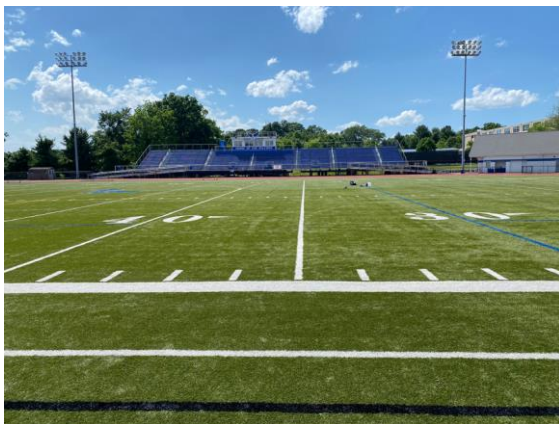
Location #7

| Loc # | Drop # | Gmax (g's) | Location Description | Gmax Avg (g's) | Infill Depth (mm) | Surface Temp (°F) |
|---|---|---|---|---|---|---|
| 7 | 1 | 133 | North Team area, Side D | 145 | 33 | 96 |

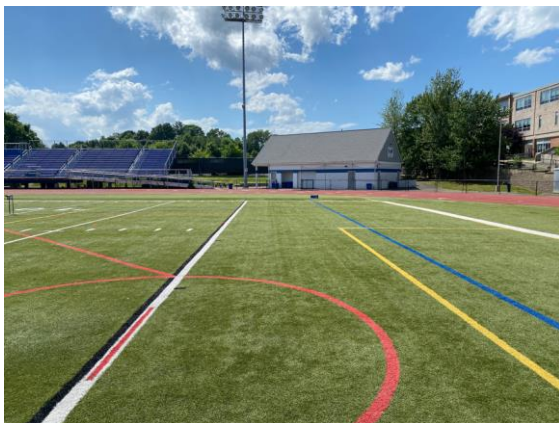
Location #9

| Loc # | Drop # | Gmax (g's) | Location Description | Gmax Avg (g's) | Infill Depth (mm) | Surface Temp (°F) |
|---|---|---|---|---|---|---|
| 9 | 1 | 140 | 6 ft from Goal Line to the back of the End Zone, End A, field centerline | 149 | 35 | 92 |

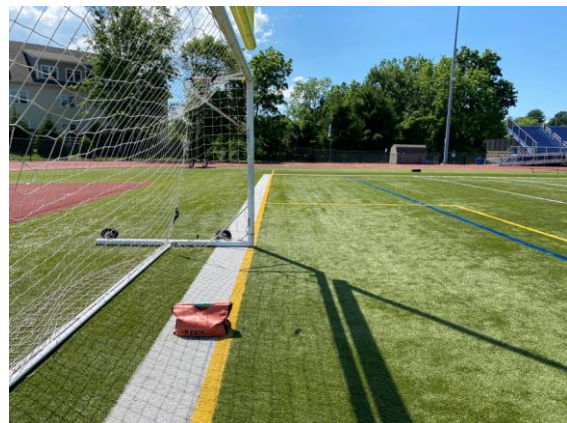
Location #10

| Loc # | Drop # | Gmax (g's) | Location Description | Gmax Avg (g's) | Infill Depth (mm) | Surface Temp (°F) |
|---|---|---|---|---|---|---|
| 10 | 1 | 154 | 6 ft from the back of the End Zone to the Goal Line, End B, field centerline | 168 | 33 | 92 |
