# ON-SITE TESTING g-MAX IMPACT EVALUATION

| <b>Project Name</b> | Fairfield Warde High School Football Field<br>ASTM F1936-19 g-max Impact Evaluation | | |
| <b>Client Info</b> | Fairfield Public Schools<br>501 Kings Hwy. E Suite 210<br>Fairfield, Connecticut 06825 | <b>Site Info</b> | Fairfield Warde High School<br>755 Melville Ave<br>Fairfield, CT 06825 |
| <b>Report Date</b> | 6/21/2022 | <b>Test Date</b> | 6/17/2022 |

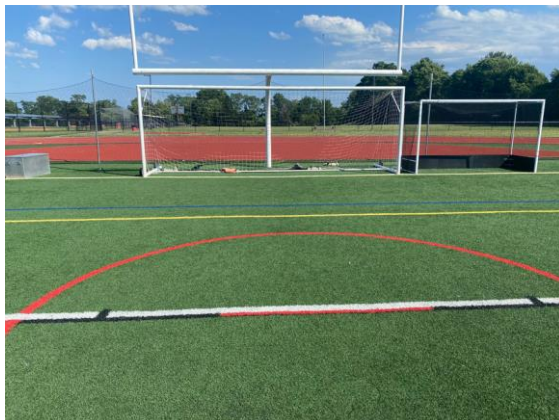
Location #1

| Loc # | Drop # | Gmax (g's) | Location Description | Gmax Avg (g's) | Infill Depth (mm) | Surface Temp (°F) |
|---|---|---|---|---|---|---|
| 1 | 1 | 151 | Goal Line, End A, field centerline | 165 | 28 | 93 |
| | 2 | 161 | | | | |
| | 3 | 169 | | | | |

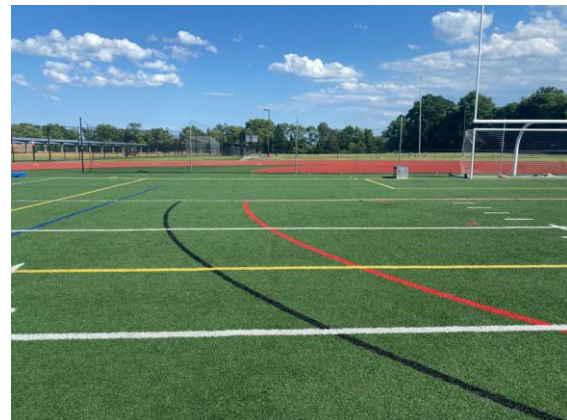
Location #2

| Loc # | Drop # | Gmax (g's) | Location Description | Gmax Avg (g's) | Infill Depth (mm) | Surface Temp (°F) |
|---|---|---|---|---|---|---|
| 2 | 1 | 122 | 10 Yard Line, End A, 63 ft from field centerline to the Side C | 140 | 30 | 92 |
| | 2 | 135 | | | | |
| | 3 | 144 | | | | |

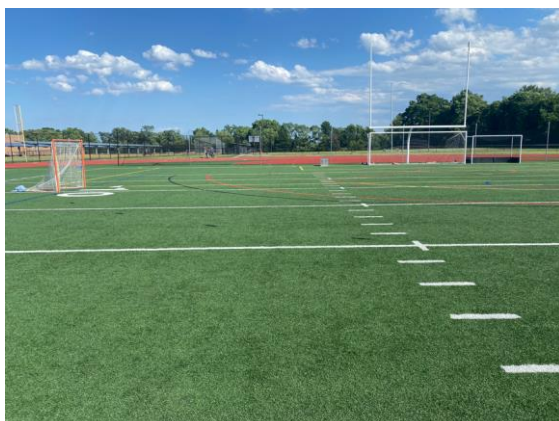
Location #3

| Loc # | Drop # | Gmax (g's) | Location Description | Gmax Avg (g's) | Infill Depth (mm) | Surface Temp (°F) |
|---|---|---|---|---|---|---|
| 3 | 1 | 131 | 25 Yard Line End A, 40 ft from field centerline to Side C | 144 | 29 | 92 |
| | 2 | 143 | | | | |
| | 3 | 145 | | | | |

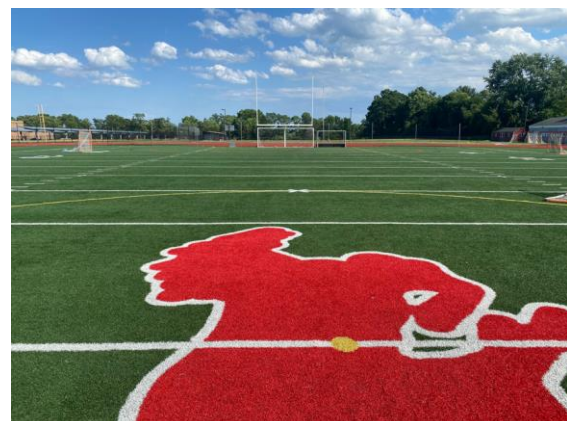
Location #4

| Loc # | Drop # | Gmax (g's) | Location Description | Gmax Avg (g's) | Infill Depth (mm) | Surface Temp (°F) |
|---|---|---|---|---|---|---|
| 4 | 1 | 138 | field centerline | 152 | 29 | 95 |
| | 2 | 149 | | | | |
| | 3 | 155 | | | | |

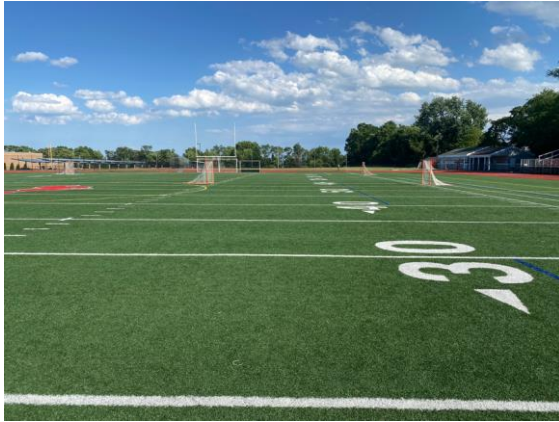
Location #5

| Loc # | Drop # | Gmax (g's) | Location Description | Gmax Avg (g's) | Infill Depth (mm) | Surface Temp (°F) |
|---|---|---|---|---|---|---|
| 5 | 1 | 124 | 25 Yard Line, East end, 63 ft from field centerline to Side D | 136 | 30 | 94 |
| | 2 | 132 | | | | |
| | 3 | 140 | | | | |

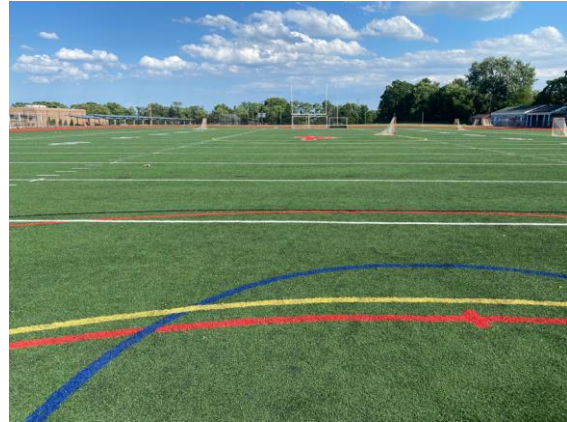
Location #6

| Loc # | Drop # | Gmax (g's) | Location Description | Gmax Avg (g's) | Infill Depth (mm) | Surface Temp (°F) |
|---|---|---|---|---|---|---|
| 6 | 1 | 116 | 12 Yard Line, End B, field centerline | 129 | 32 | 96 |
| | 2 | 126 | | | | |
| | 3 | 131 | | | | |

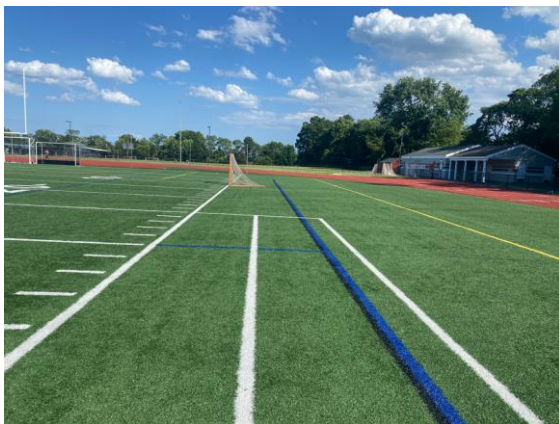
Location #7

| Loc # | Drop # | Gmax (g's) | Location Description | Gmax Avg (g's) | Infill Depth (mm) | Surface Temp (°F) |
|---|---|---|---|---|---|---|
| 7 | 1 | 134 | North Team area, Side D | 149 | 29 | 94 |
| | 2 | 147 | | | | |
| | 3 | 150 | | | | |

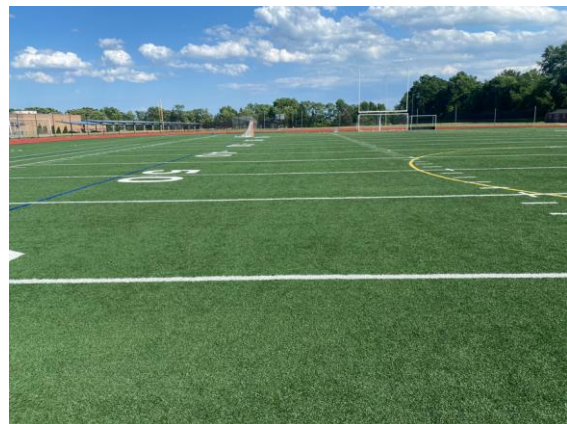
Location #8

| Loc # | Drop # | Gmax (g's) | Location Description | Gmax Avg (g's) | Infill Depth (mm) | Surface Temp (°F) |
|---|---|---|---|---|---|---|
| 8 | 1 | 118 | 37 Yard Line, End B, 40 ft from the field centerline to Side C | 131 | 31 | 92 |
| | 2 | 129 | | | | |
| | 3 | 132 | | | | |

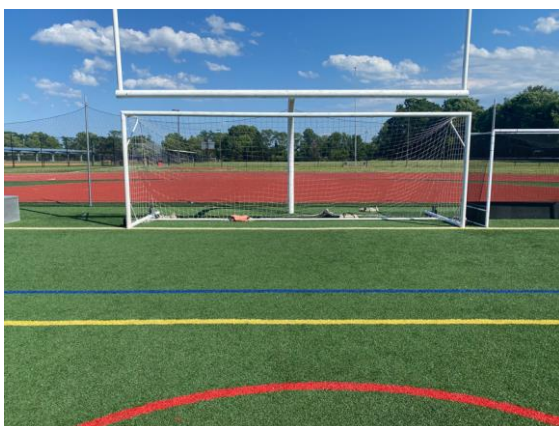
Location #9

| Loc # | Drop # | Gmax (g's) | Location Description | Gmax Avg (g's) | Infill Depth (mm) | Surface Temp (°F) |
|---|---|---|---|---|---|---|
| 9 | 1 | 126 | 6 ft from Goal Line to the back of the End Zone, End A, field centerline | 144 | 29 | 93 |
| | 2 | 141 | | | | |
| | 3 | 146 | | | | |

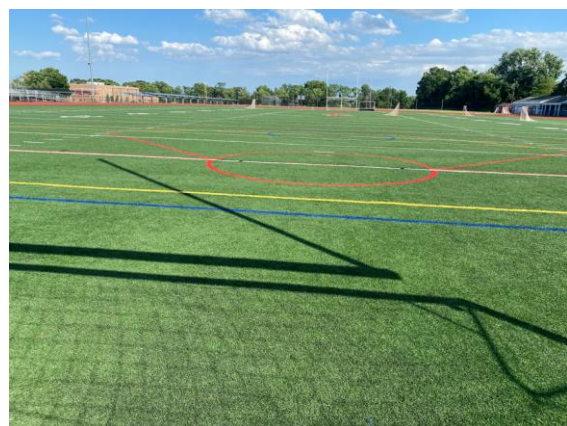
Location #10

| Loc # | Drop # | Gmax (g's) | Location Description | Gmax Avg (g's) | Infill Depth (mm) | Surface Temp (°F) |
|---|---|---|---|---|---|---|
| 10 | 1 | 132 | 6 ft from the back of the End Zone to the Goal Line, End B, field centerline | 144 | 28 | 94 |
| | 2 | 143 | | | | |
| | 3 | 144 | | | | |
